# **Monitoring and Assessing the Long-term Environmental and Use Impacts on Selected Mountain Bike Trails in South Australia**

**Final Report  
prepared for  
Mountain Bike Australia**

**by  
Stuart Clement  
Stuart Clement Solutions**

12 March 2010

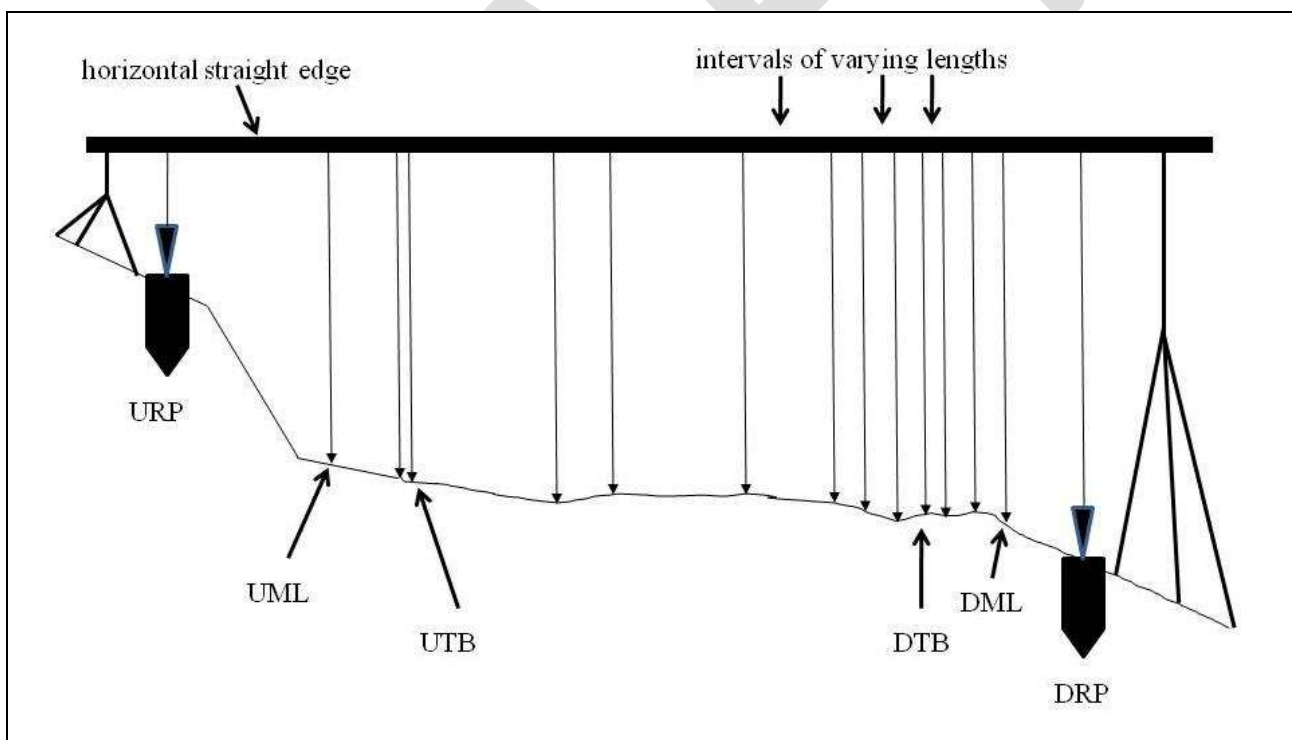
Figure 5 Diagram of the variable interval cross-sectional area method

Figure 5 shows a representation of a trail profile with the natural line of the hillside to the extreme left and right of the diagram. The horizontal straight edge is supported by tripods. The plumb bobs are shown over the reference pegs URP and DRP. The used tread width boundaries are indicated with UTB and DTB and the full measuring width boundaries 20cm each side of the used tread width are indicated with UML and DML.

The method for determining each measuring point along the transect follows that given in Marion and Olive (2006) called the “variable interval cross-sectional area method”. This method reduces the profile of the tread across the trail to a series of connected straight lines between the points where the transect visibly changes its slope (see Figure 5). This method in the majority of cases enables a more complete and accurate calculation of the cross-sectional area than measuring at points at regularly-spaced intervals (eg every 50mm) across the transect.

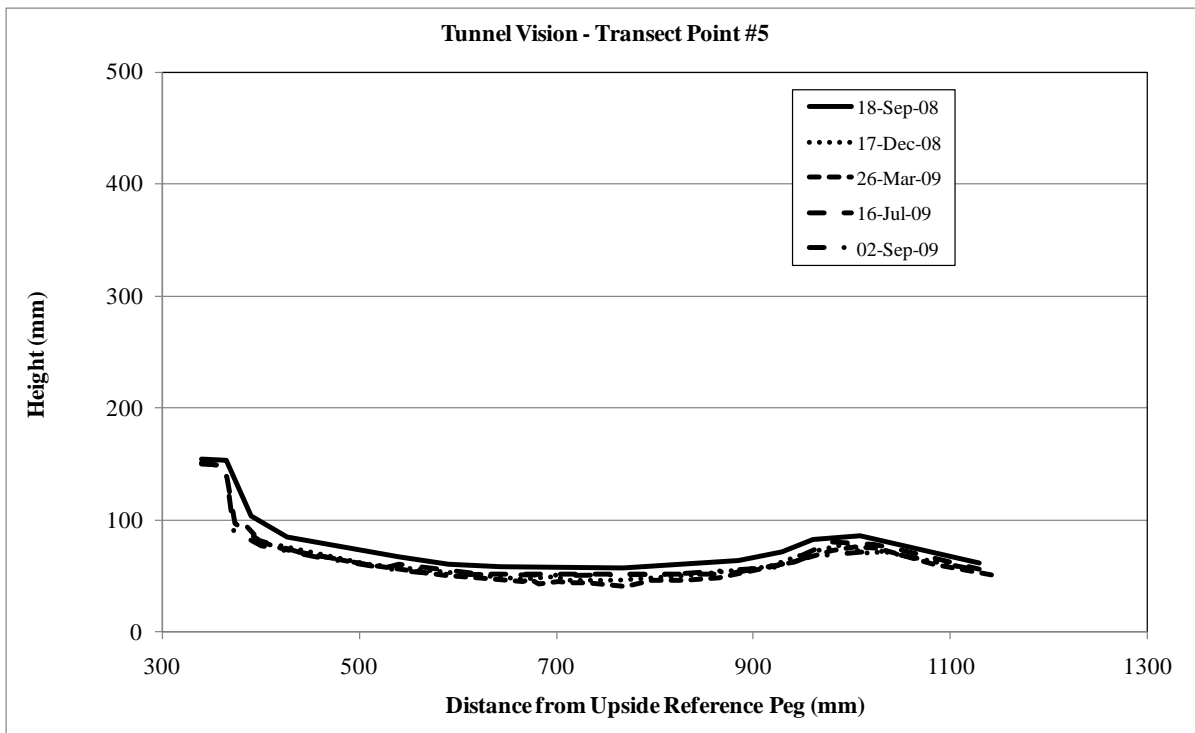
**Figure 8 Example of a consistent set of transect profiles**

An example of this vertical shift due to measurement error in the URP of the baseline survey is given in Figure 8 where it could appear that the entire width of the trail is wearing and eroding at a remarkably similar rate. This is unlikely to occur and is not the case here. The mean change in used tread width profile area values associated with transect point #5 on *Tunnel Vision* when Survey #1 is compared with the four later surveys are: -1.0, -1.3, -0.7 and -0.8 cm<sup>2</sup>/cm respectively. If the measurement for the height of the URP is in error by 9mm in the first survey then the four compared values become: -0.1, -0.4, 0.2, and 0.1 cm<sup>2</sup>/cm and the subsequent graph is more akin to that of Figure 7 describing transect point #1 (ie the vertical displacement between each profile line on the graph is much smaller than in Figure 8). Hence where the profiles have very similar shape but are vertically displaced, the profiles are described as ‘consistent’.

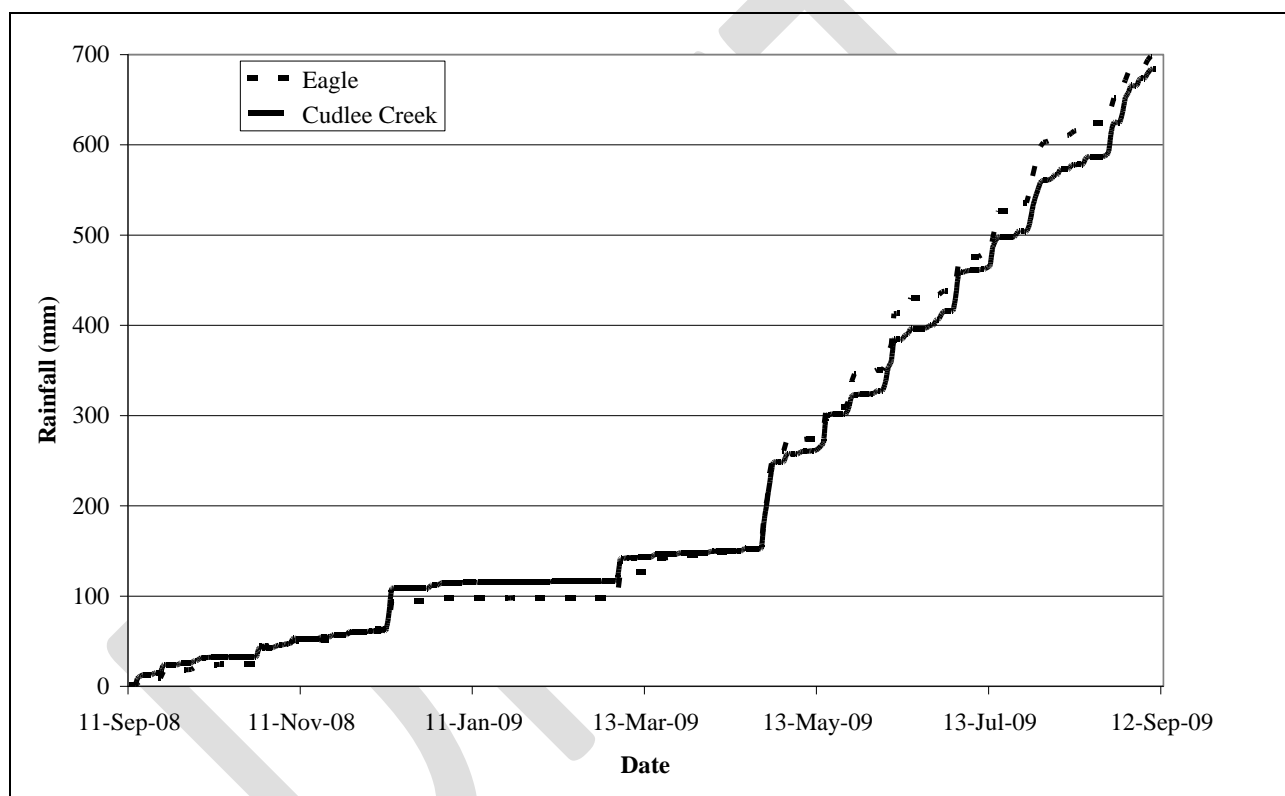
Figure 9 Cumulative rainfall data from the BoM stations nearest the study areas

The rainfall patterns for the study areas are similar: some small falls through the Spring of 2008; heavy, short-duration falls in December, March and April with minimal precipitation in between; then regular falls through the winter of 2009 into the Spring.

The Eagle-on-the-Hill station recorded 698 mm over the study period (11 September 2008 to 10 September 2009) and the Stringybark station recorded 684mm. This represents a difference of just over 2 per cent. The cumulative rainfall curves for both weather stations are shown in Figure 9.

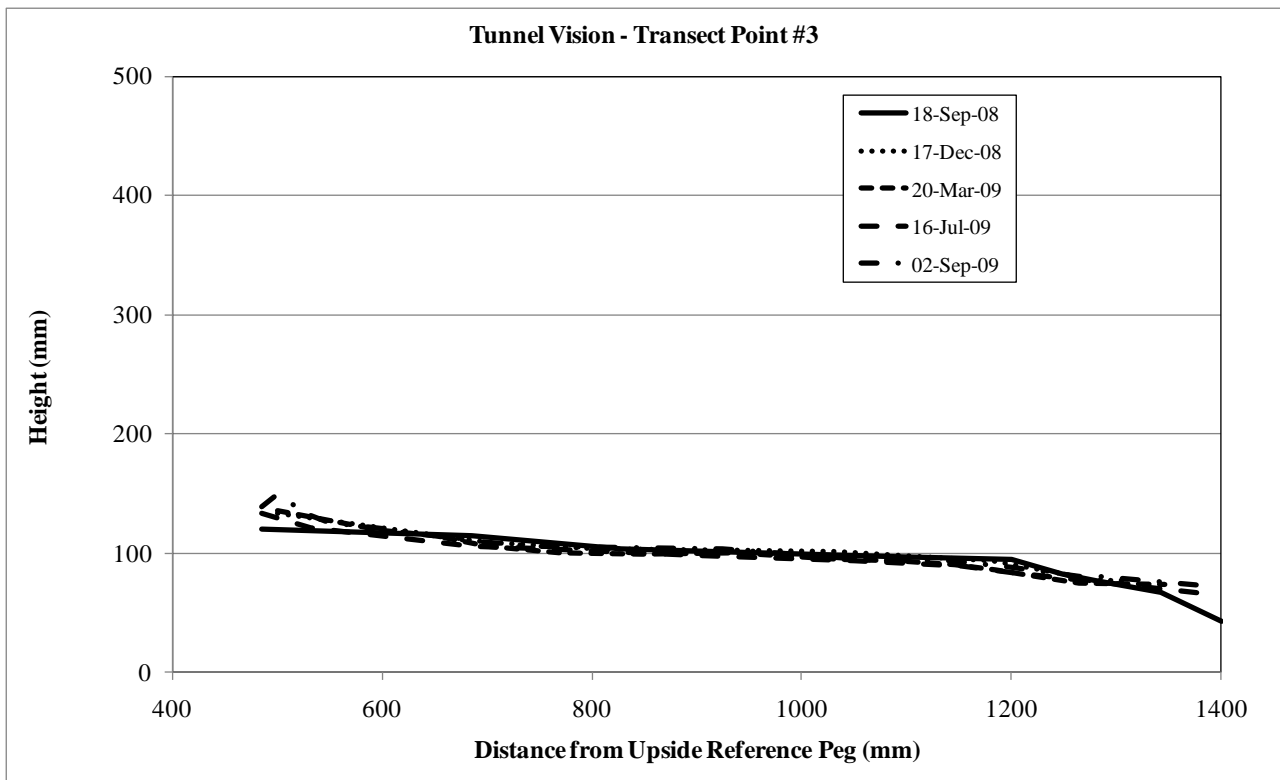
**Figure 12 TV-3 transect profile changes showing minor but insignificant changes on the downslope side**

Conclusion: minor, insignificant change.

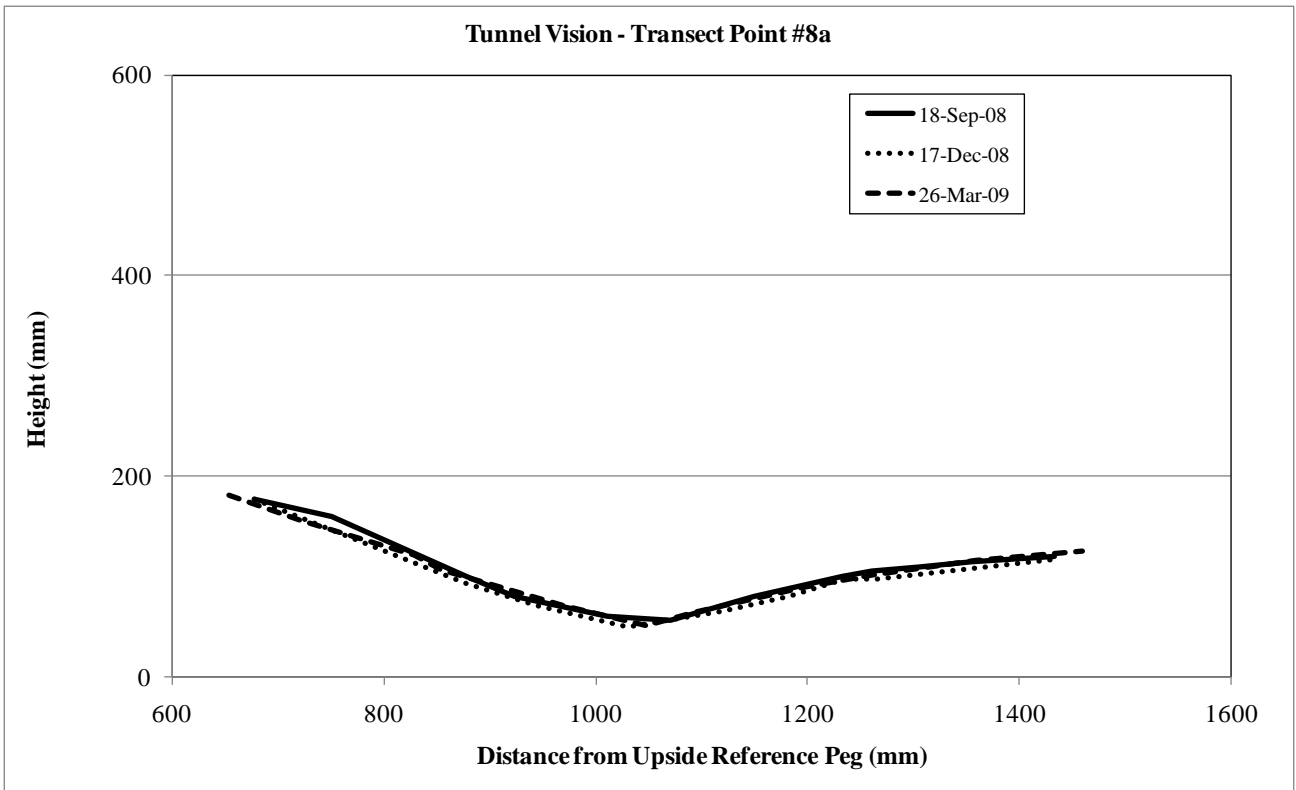
**Figure 14 TV-8 before the reshaping work on 26 March 2009**

### **Figure 13 TV-8 before (March 2009) and after (September 2009) the removal of the rock and the reshaping work of 26 March 2009**

Conclusion: minor change due to the tread bedding in after alterations (see Figure 15).

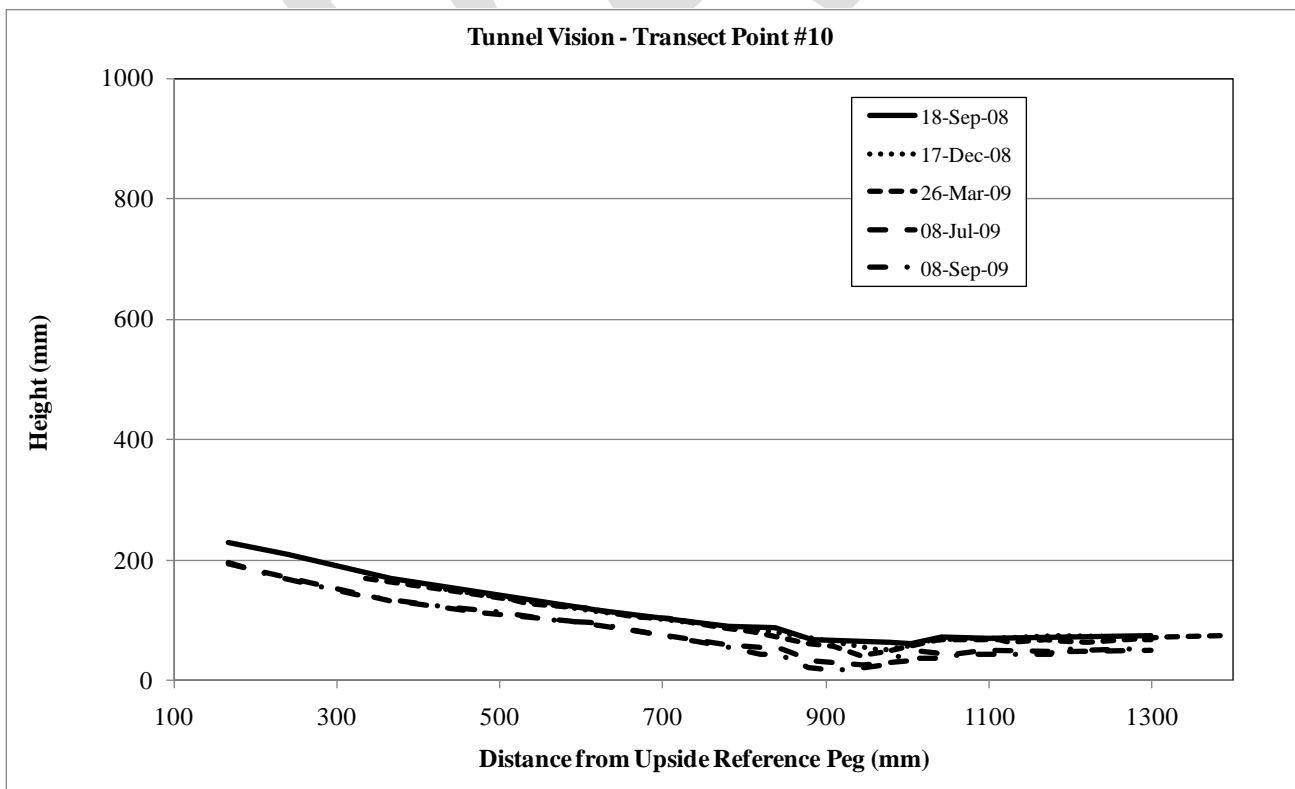
**Figure 17 TV-10 profiles**

Conclusion: significant change.

**Figure 16 TV-10 in September 2008 and September 2009 showing the effects of soil movement**

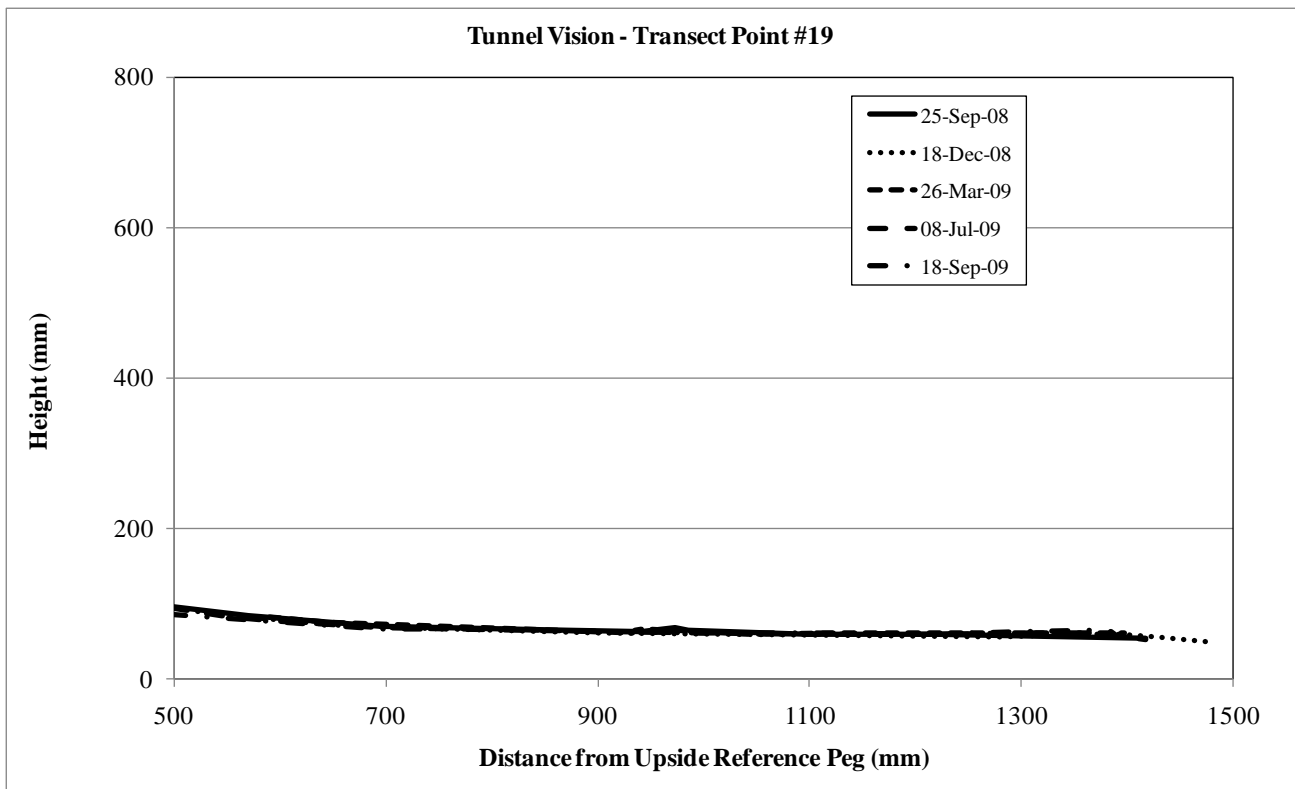
**Figure 19 TV-19 profiles**

Conclusion: no change.

### **Figure 18 TV-19 in September 2008 and the surface in September 2009**

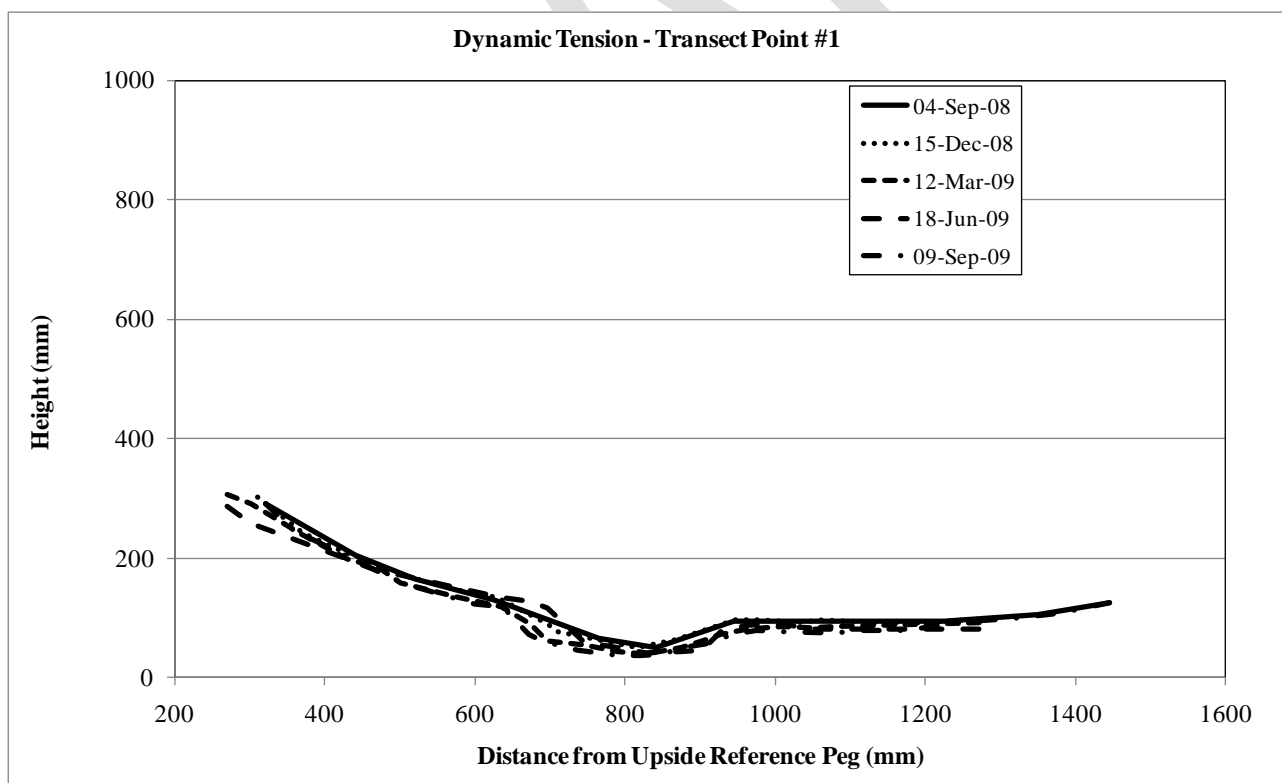
Figure 20 Dynamic Tension transect point #1 profiles

The trail to fall line angle is small at about 55° and the distance to the grade reversal when climbing on the trail away from the transect point (the uptrail grade reversal) is about 8 metres. At the first survey in September 2008 there was a noticeable channel where soil loss from the used tread had occurred (Figure 20). This deepened and widened slightly between September and December 2008 during which time the trail experienced about 12 per cent of the rainfall and its mean use per day was 10 to 11 riders or about 22 per cent of total estimated use.

The channel further deepened and widened by March 2009 during which time the trail experienced approximately 9 per cent of rainfall and about 9 riders per day (about 16 per cent of total use). After experiencing some soil loss in the first half of the study the transect point profile now appears to be stable. There was no discernible change in the profile between March and June 2009. This period included the *Dirty Weekend* event when about 51 per cent of the usage for the study year occurred.

Figure 21 Dynamic Tension transect point #1 in September 2008 and September 2009 showing the widening of the riding channel

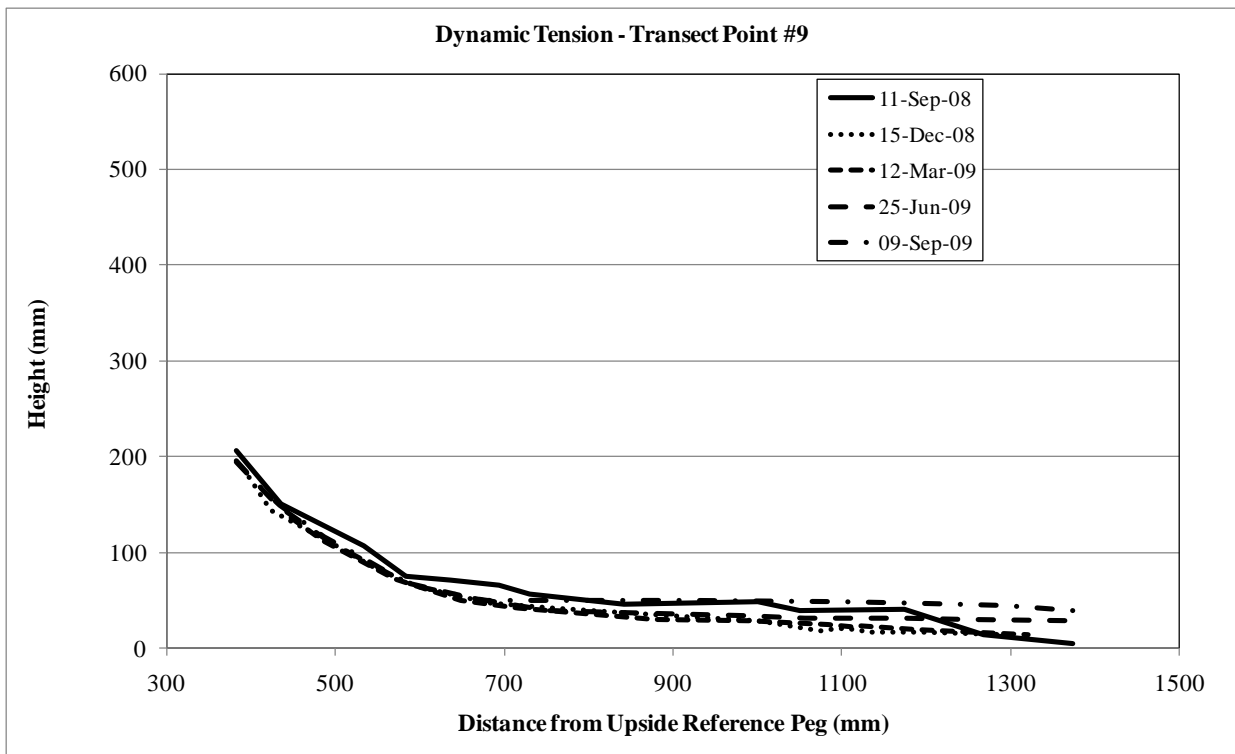
**Figure 22** *Dynamic Tension* transect point #9 profiles

Transect point #9 is the other point that revealed significant change over the course of the study: it exhibited both soil loss and gain. The point is at the foot of a descending, right-hand curve of the trail and is at a drainage point on the turn leading into a left-hand descending turn (gradients of 1 and 4 per cent either side). The mean change values and the transect profile graphs indicate soil loss from September to December 2008 (about 12 per cent of rainfall and about 22 per cent of riders over this period) then deposition from June to September 2009 (40 per cent of the rainfall occurred in this period and about 12 per cent of riders) (see Figure 22 for transect profiles and Figure 23 for a snapshot taken in June 2009). These changes resulted in a nett zero change in transect profile area over the study period. The surface is soil with embedded small stones that help secure the soil. The used tread width has not changed and the tread started with slight outslope and is now almost flat from sediment deposition at the drain point. The trail to fall line angle is about 60° and the long side uptrail grade reversal distance is 17m (in this case towards the start of the trail). The shape of the tread for about 10m on the uptrail side is concave and this, coupled with the low trail to fall line angle would not allow water to run off the trail but induce it to move down to the transect point. The profile measurements, backed by the photographic record and notes taken during the study show that this water does carry some sediment that is deposited at the drain at the transect point.

**Figure 23** *Dynamic Tension* transect point #9 in June 2009

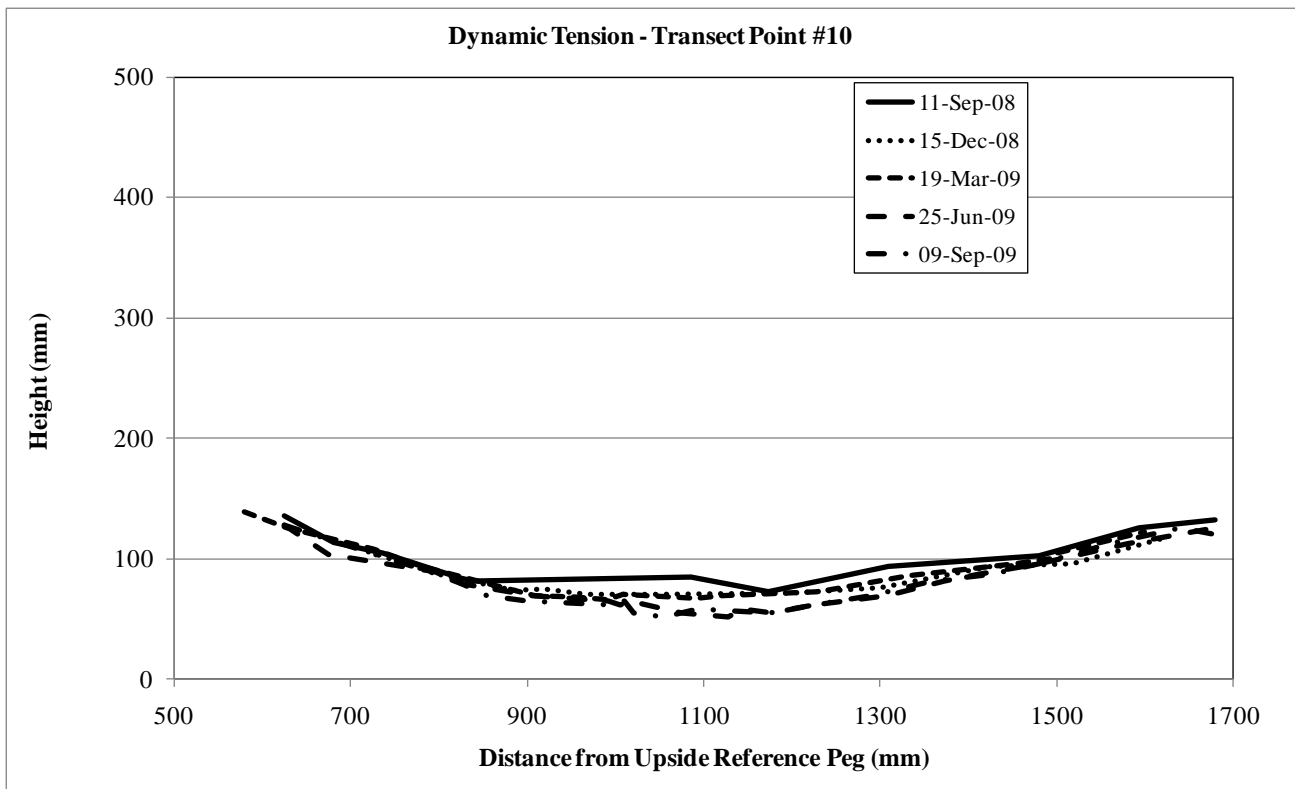
**Figure 25 DT-10 profiles showing the soil loss between September and December 2008**

This transect point is at the exit of a right-hand descending turn about one metre before a trail drainage point which is just before a left-hand turn. The gradient is quite steep at 12 per cent for 2 metres of the 10 m to the uptrail grade reversal. The surface is hard soil with many small stones; some embedded and some loose (Figure 24). The mean change values and graphs (Figure 25) indicate some soil loss between September and December 2008 and possibly more loss between March and June 2009. The tread is concave and the used tread width has narrowed by 18 per cent. The trail to fall line angle is 75°.

Conclusion: minor, insignificant change.

**Figure 24** DT-10 in December 2008 and September 2009

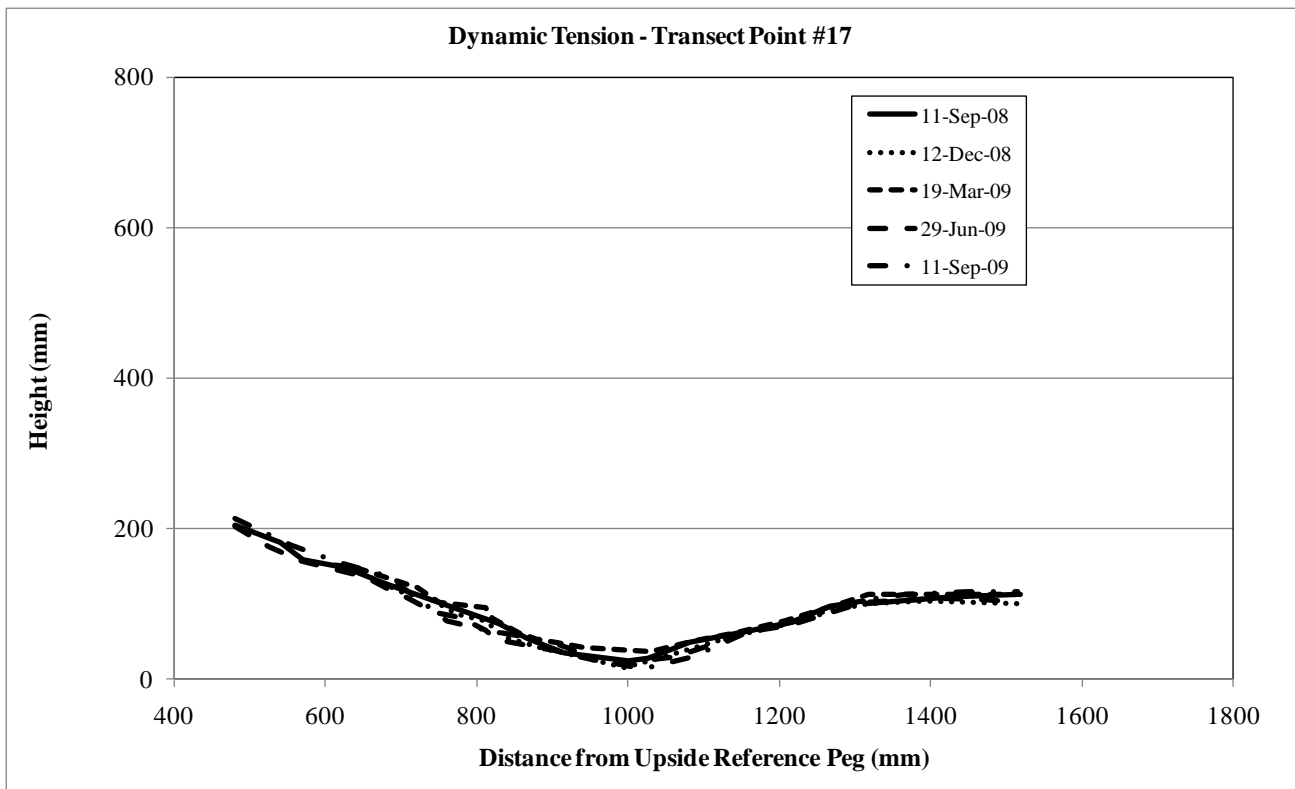
**Figure 27 DT-17 profiles**

This transect point is on a part of the trail that is a descending left-hand curve with a relatively steep gradient of 20 per cent. The trail to fall line angle is 14° and it is clear that considerable wear and erosion occurred before this study commenced (see Figure 26 for a visual indication). Perhaps unexpectedly, over the course of the study little change occurred (profiles are reasonably consistent – see Figure 27 – and the mean change values are within expected variation) indicating the trail at this transect point is holding up to wear and weather. The distance to the uptrail grade reversal is 9 metres. The surface is packed soil with embedded and loose small stones. The tread at this transect point is the most concave of the *Dynamic Tension* points. The used tread width has not changed.

Conclusion: no change.

**Figure 26 DT-17 in August 2008 and September 2009 showing no change despite the minimal trail to fall line angle. Note the concave tread profile**
