**Gap Creek Circuit  
Mountain Bike Trail:  
Long Term Environmental  
and Use Impacts**

prepared for  
**Gap Creek Trails Alliance**

by  
**Stuart Clement Solutions  
Adelaide  
South Australia**

**26 October 2010**

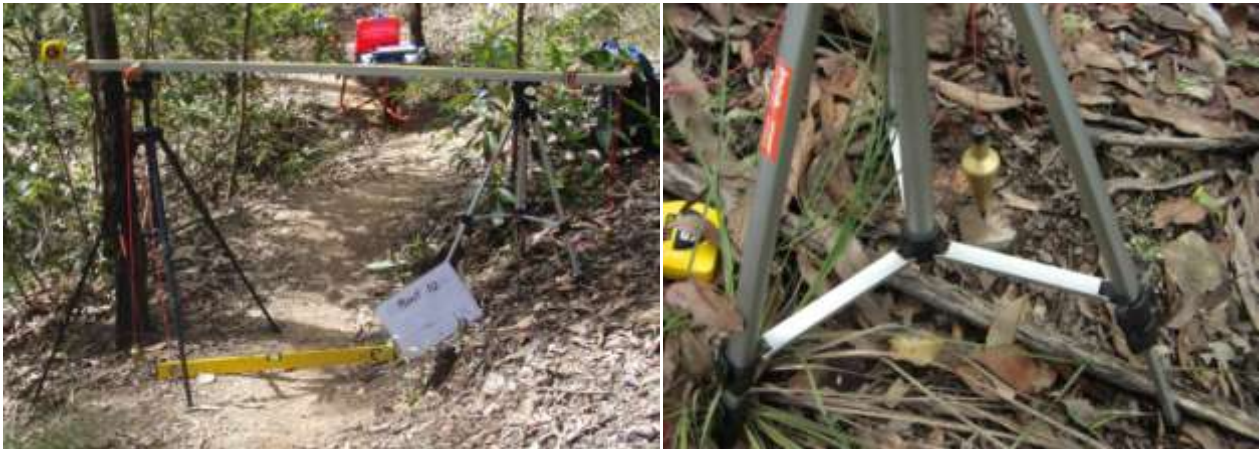
**Figure 1** Transect profile measurement setup

pegs. Accuracy is achieved using plumb bobs dropped from the straight edge to the pegs (Figure 1). Similarly, the vertical distance from the straight edge to the trail surface is found by dropping a plumb bob to the trail surface. A flat, steel tape measure is clamped to the top of the beam, and positioned so that the horizontal distance of each measuring point from the upside reference peg is recorded. A view of the apparatus setup is shown in Figure 1.

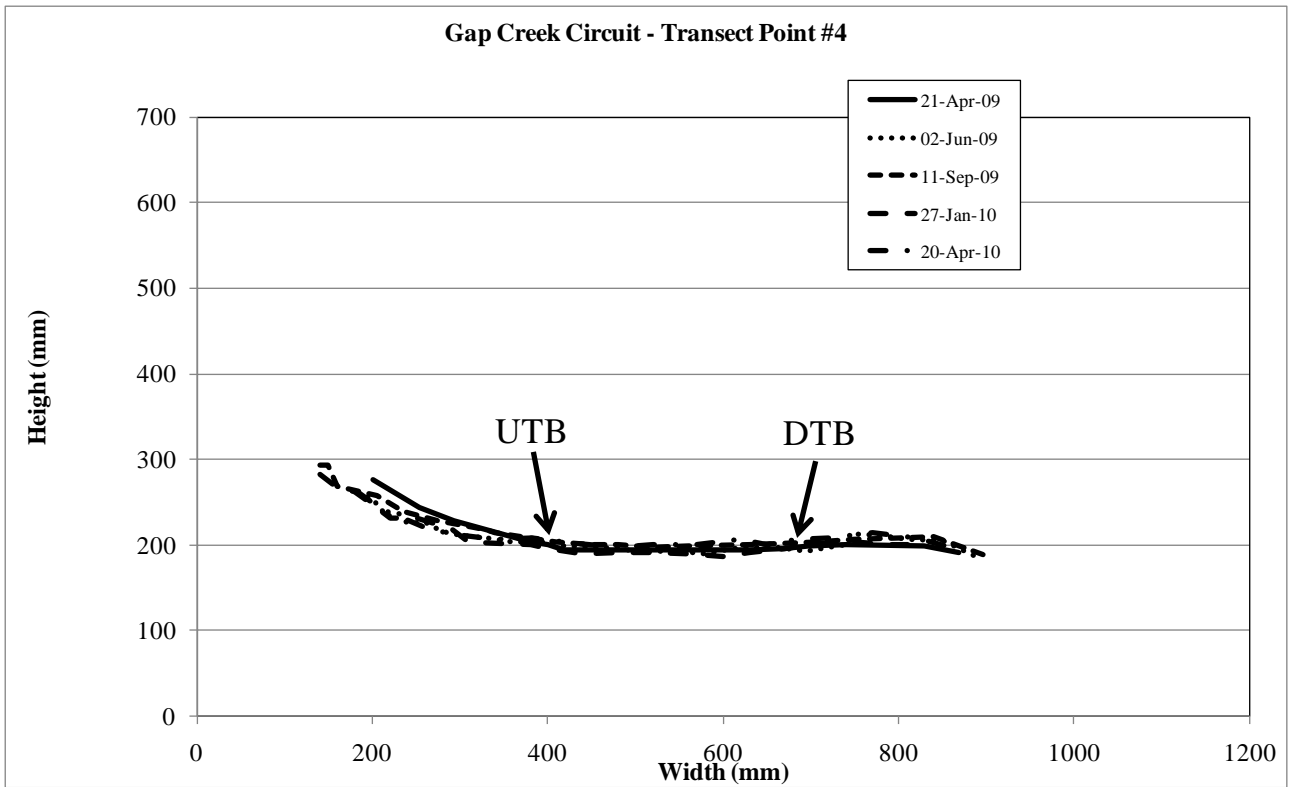
**Figure 3** Example profile graph of a transect point exhibiting no change in cross-sectional areas over the study period

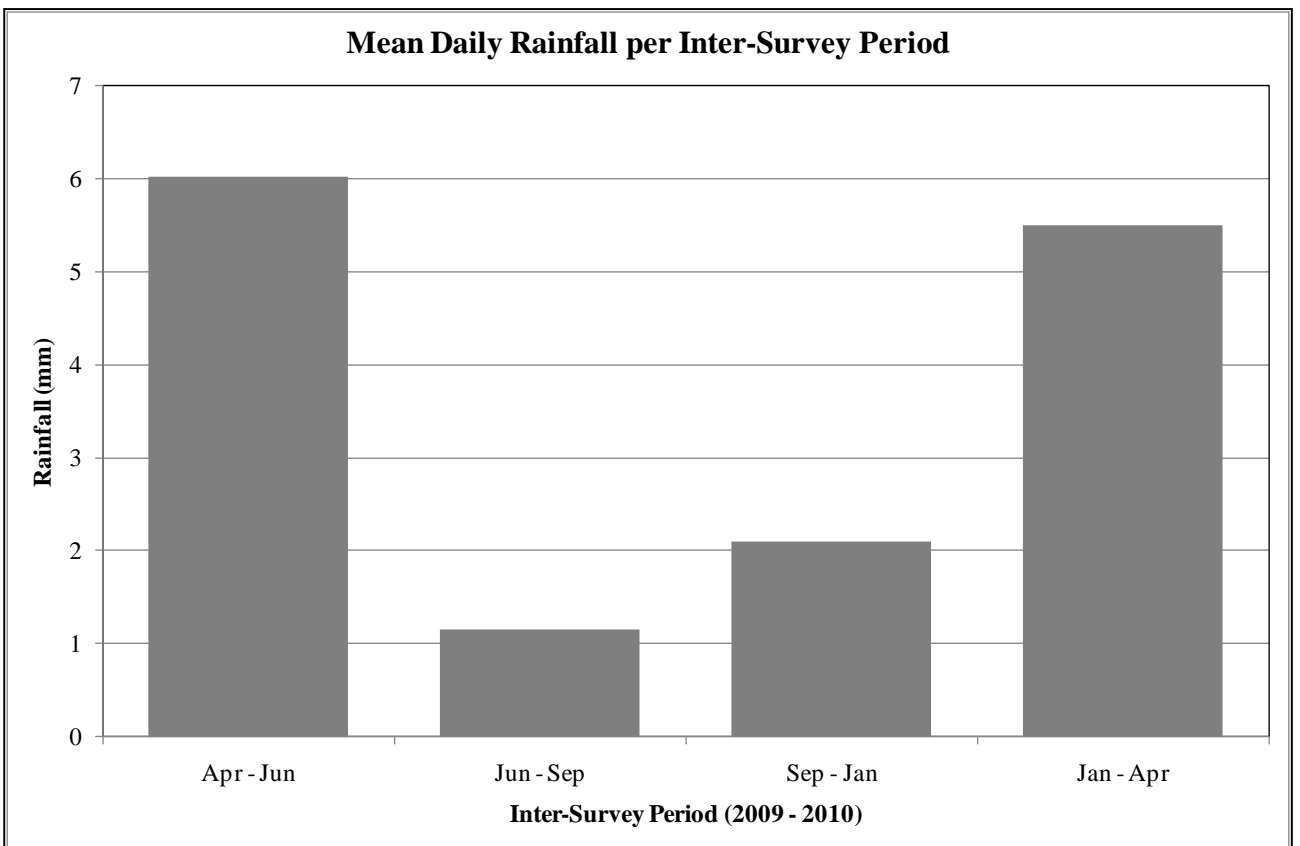
The mean daily rainfall figures between each survey are shown in Figure 5. It should be noted that there was a significant rain event over the three days of 19 – 21 May 2009 when 221.8 mm of rain fell. This equated to nearly 17 per cent of the total fall for the study year and occasioned the trail to be closed for three weeks, re-opening on 12 June. The 26-day period between the end of Survey #1 and the first day of the rain event of 19 May saw 4.0 mm of rain fall. It can be assumed that use of the trail was normal during this period though the TRAFx mountain bike counters were not installed until 12 June. See Section 6 for the reasoning behind the trail use estimates for this period. The 21-day period from after the significant rain event up to Survey #2 (2 June) was unusually wet with a further 31.4 mm falling; hence the continued closure of the trail.

**Figure 6** Mean daily rainfall over each inter-survey period

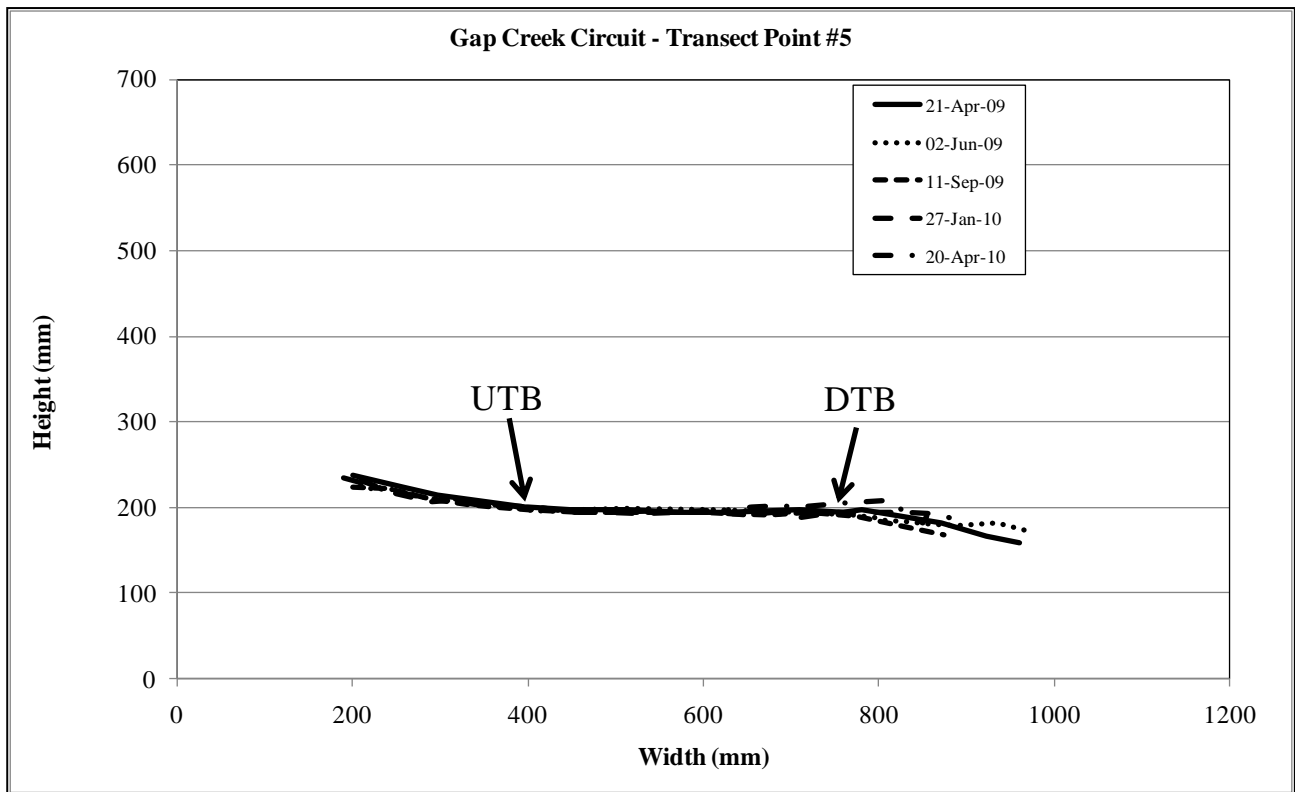
**Figure 12 GCC-5 transect profile**

Conclusion: no change.

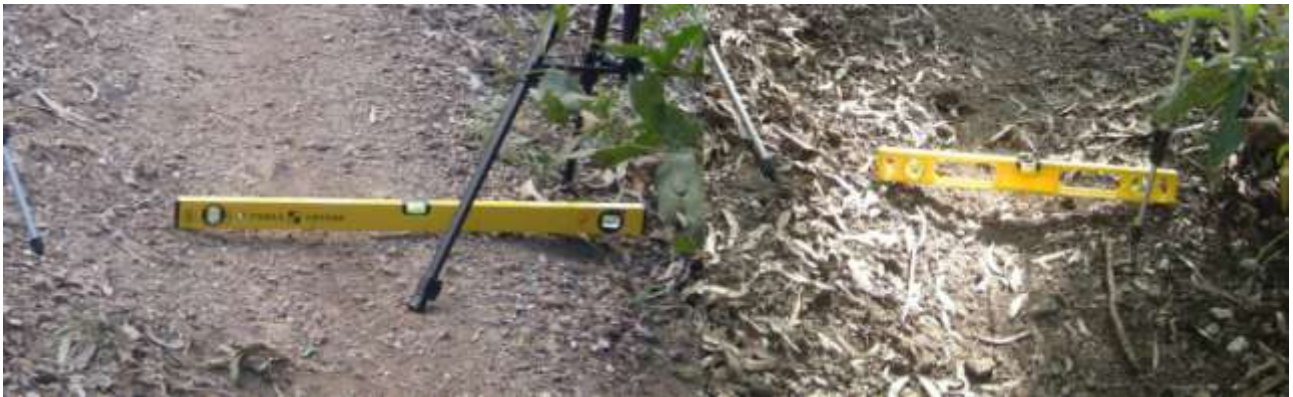
The values of mean change in profile area show that there has been significant soil loss at this transect point over the course of the study, particularly between the fourth (January 2010) and fifth (April 2010) surveys. No deep gouging is evident. The point is situated on the point of a change of grade on a steep, short section of trail with a gradient of 11 per cent in the upslope direction and -20 per cent in the other and is about 6 metres from the upslope grade reversal. The surface is typically that of *Gap Creek Circuit* with packed earth, some small, loose stones and considerable leaf litter. The concave tread profile became more pronounced over the course of the study while the used tread width diminished by 27 per cent from about 32 cm to about 23 cm.

**Figure 23 GCC-14 in April 2009 and April 2010 showing the change in profile exaggerated by the angle of the sun**

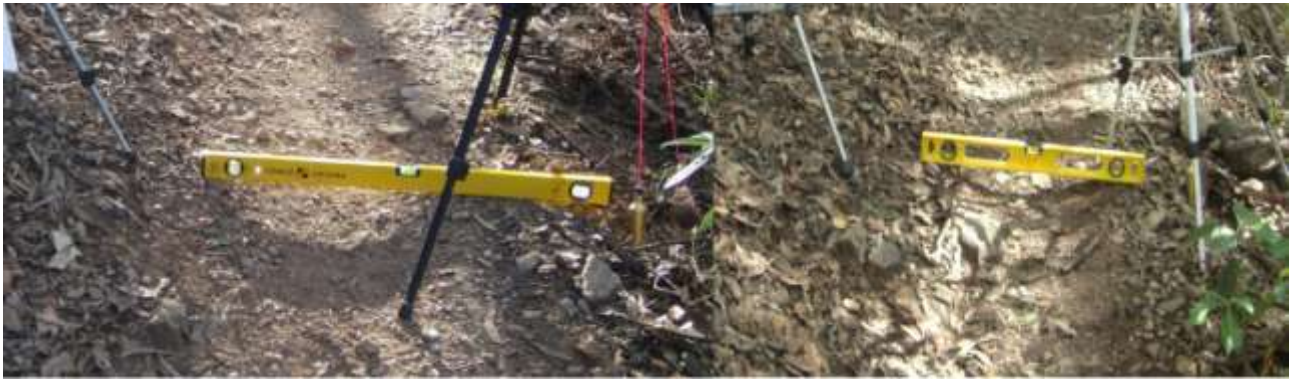
This transect point is very similar to GCC-14 in many respects: it is on a short, steep section of trail (18 per cent) not far from the upslope grade reversal; its surface is similar; and the profile has changed towards the downside of the used tread. As with GCC-14 the most soil loss occurred between the fourth (January 2010) and the fifth (April 2010) surveys. No deep gouging is evident. The values of the mean change in profile area show significant soil loss over the used tread and the measuring limit. The profiles indicate most of the loss has occurred towards the downside of the trail and into the area outside the tread as judged in the baseline study. The used tread width has increased only from 26 to 29 cm and its upper and downslope boundaries have altered little. The profile has become more concave over the course of the study. This transect point has a small trail to fall line angle of 40 degrees.

**Figure 24** GCC-15 in April 2009 and April 2010 showing the change in profile
